DAMAGE AND CONDITION ASSESSMENT

DESIGNS AND ENGINEERED SOLUTIONS, LLC 114 SCOVILLE HILL ROAD, HARWINTON, CT Phone: 860.806.2094 email: MATTHEWSZYLO@GMAIL.COM	SCALE AS NOTED COM. NO. 17-106 DRAWN BY MCS DATE 05-23-17	BELL TOWER EVALUATION NORFOLK CONGREGATIONAL CHURCH BUILDING PLAN AND TOWER ELEVATION	DRAWING 5-1 SHEET NO. 1 NO. OF SHEETS 2
REV.	DESCRIPTION OF REVISION	DATE	APPR

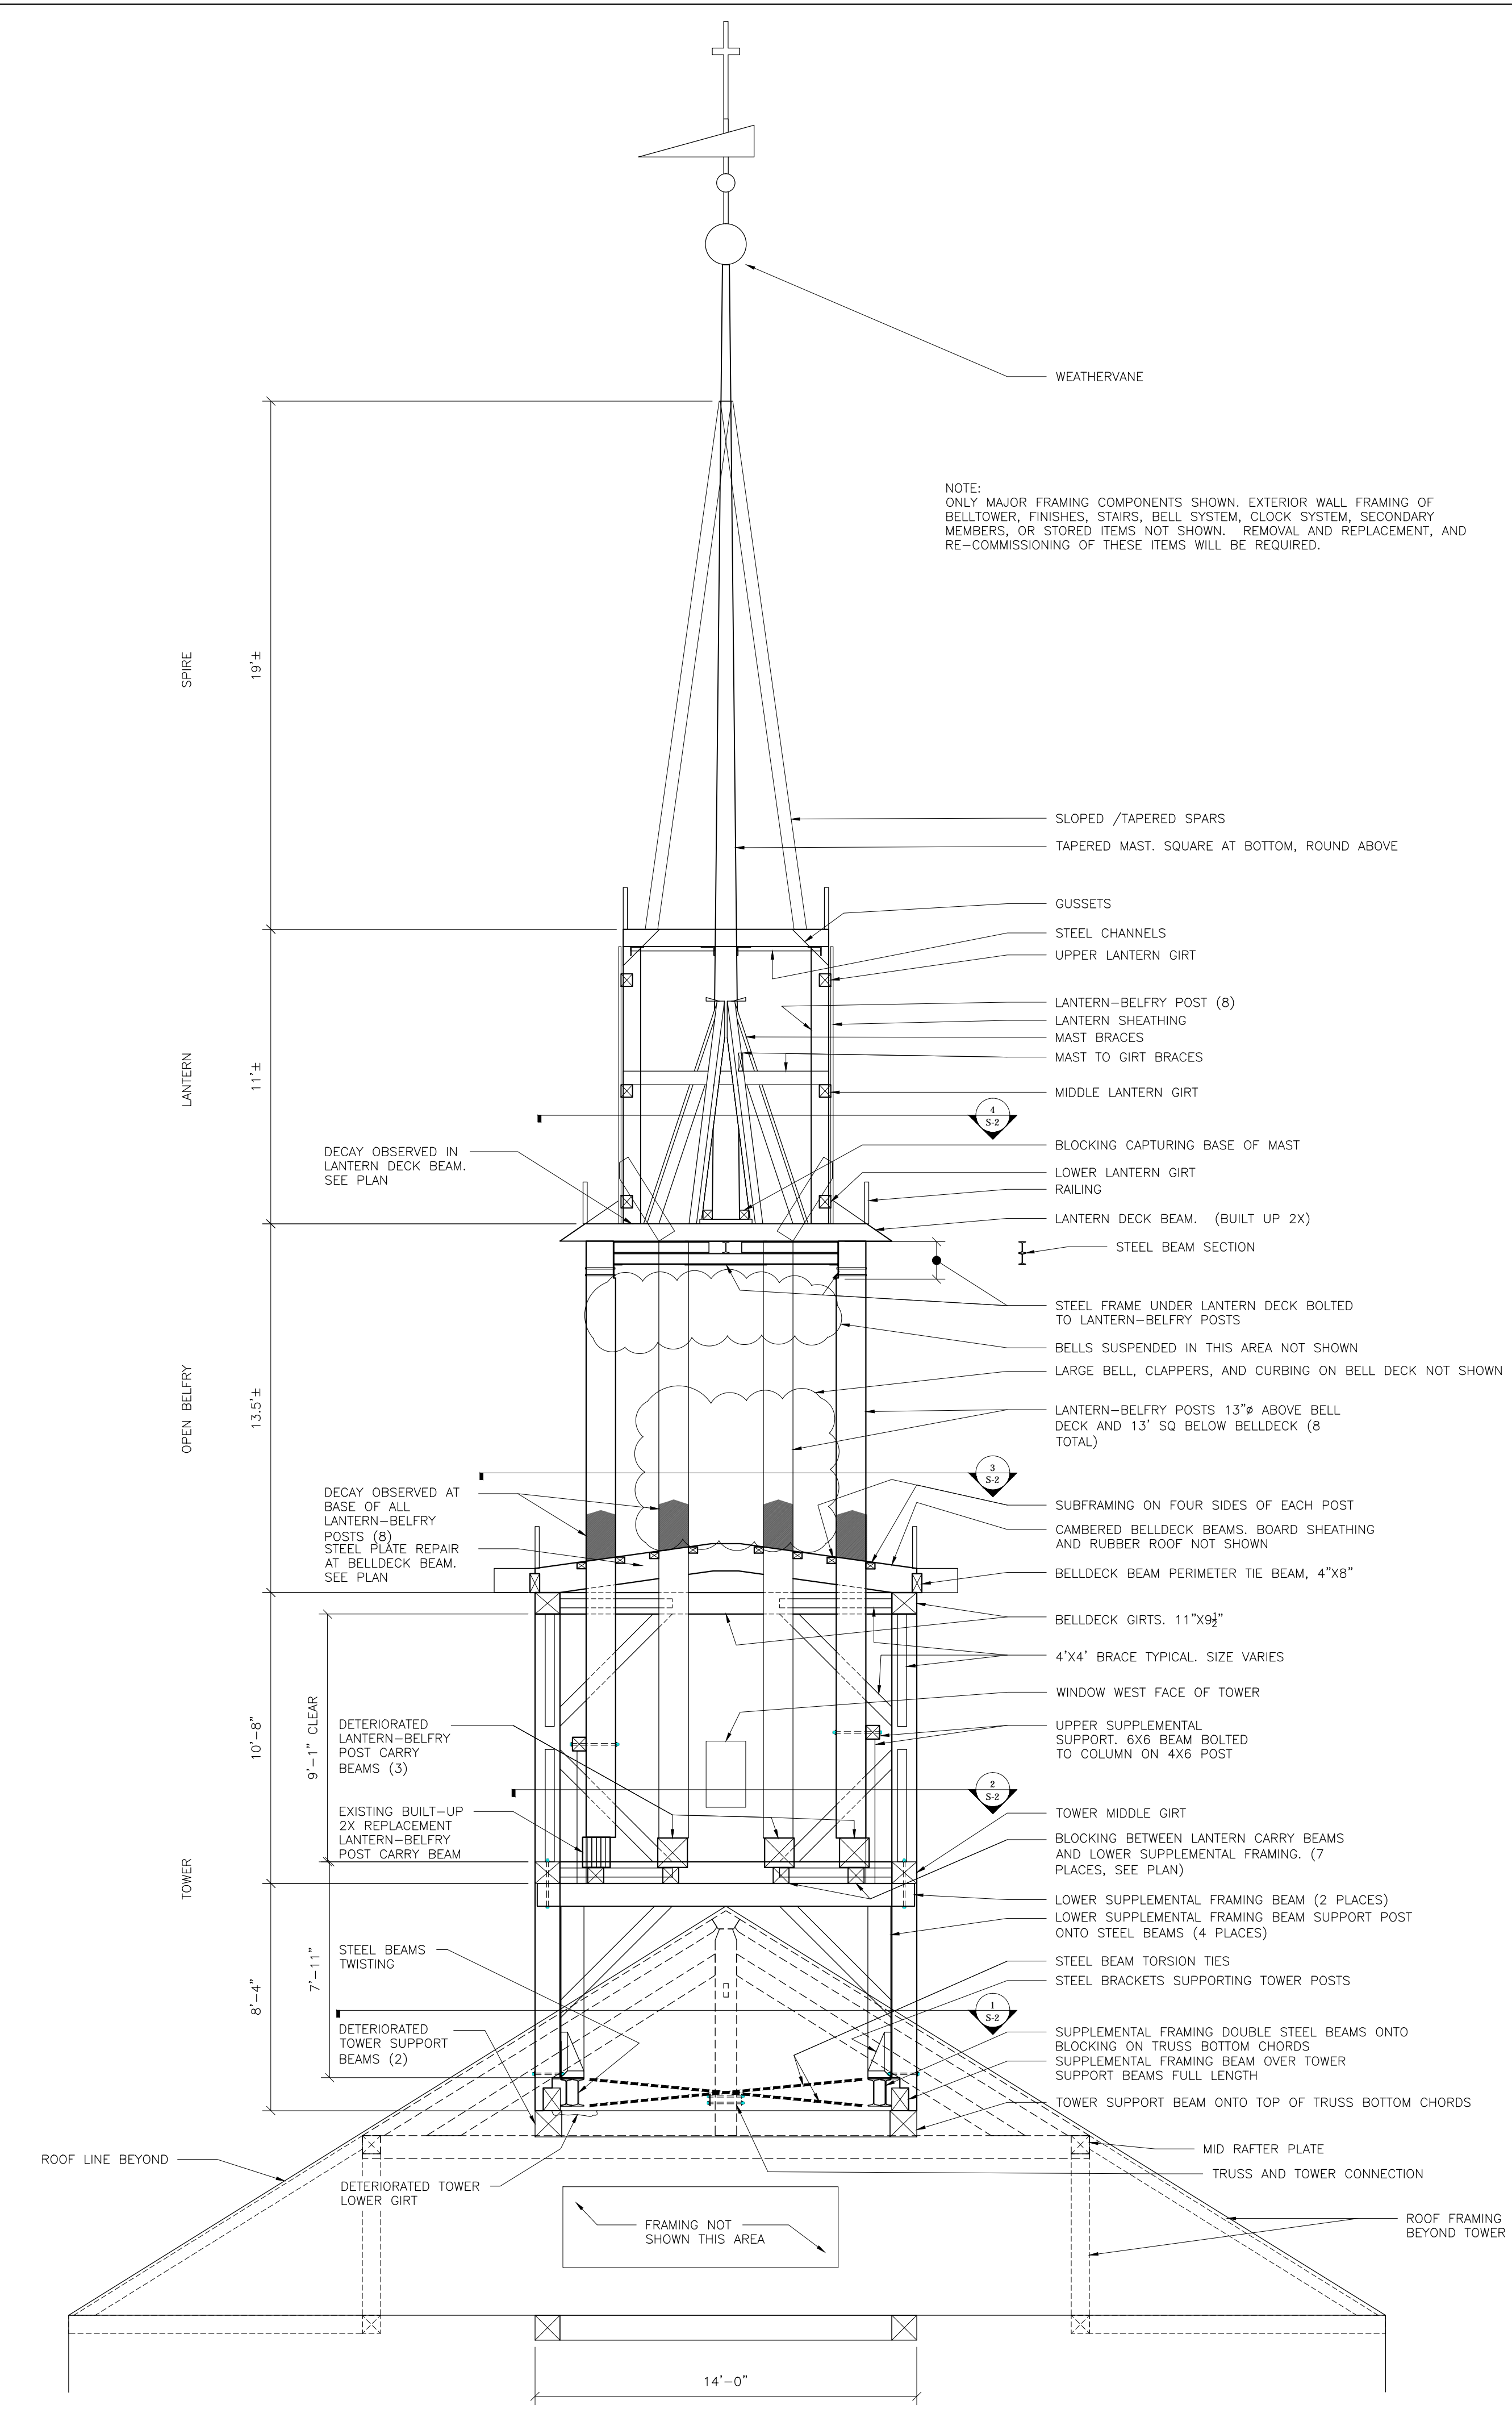
3 BELL TOWER SECTION AT WEST (REAR) FACE
SCALE: 1/4"=1'-0"

- LANTERN-BELFRY POSTS**
(8) POSTS 13" SQUARE AND DIAMETER. DECAY CONDITIONS FOUND AT BELLDECK LEVEL UP TO TWO FEET ABOVE. LOSS OF SIGNIFICANT PORTIONS OF CROSS SECTION (GREATER THAN 50% IN SOME CASES). CONDITION ABOVE THIS UNKNOWN.

- LANTERN-BELFRY POST BEAMS**
(3) OF (4) BEAMS EXHIBITED SIGNIFICANT DECAY. THE BEAMS THEMSELVES PROVIDE MINIMAL TO NO SUPPORT AT THIS TIME AND ARE FUNCTIONING AS BLOCKING TO TRANSFER LOAD TO SUPPLEMENTAL SUPPORTS. (1) OF (4) BEAMS HAS BEEN REPLACED AT AN EARLIER DATE AND DOES APPEAR TO BE FUNCTIONING ADEQUATELY.

- SUPPLEMENTAL SUPPORT SYSTEM FOR LANTERN-BELFRY POST BEAMS**
THE ADDITIONAL SUPPORT SYSTEM FOR LANTERN-BELFRY POST BEAMS HAS BEEN ADDED AT A HISTORICAL TIME. THE SUPPORT SYSTEM CONSISTS OF AN UPPER AND LOWER PART. THE UPPER PART CONSISTS OF TWO BEAMS AND FOUR POSTS WHICH ARE BOLTED TO AND DIRECTLY SUPPORT LANTERN-BELFRY POSTS. THE LOWER PART CONSISTS OF BLOCKING, TWO WOOD BEAMS, FOUR WOOD POSTS, AND TWO STRUCTURAL STEEL BEAM ELEMENTS THAT SUPPORT THE LANTERN-BELFRY POST BEAMS. THE SUPPLEMENTAL SYSTEM PROVIDES ONLY PARTIAL SUPPORT FOR THE LANTERN BEAMS; POSTS AND COMPONENTS MAY BE UNDERSIZED. STEEL BEAMS EXHIBITED SOME TORSIONAL STRAINING (TWISTING).

- TOWER SUPPORT BEAMS**
ORIGINAL TOWER SUPPORT BEAMS EXHIBITED DETERIORATION AND HAVE BEEN REPLACED BY THE SUPPLEMENTAL SUPPORT SYSTEM STEEL BEAMS. BEAMS ARE TWISTING FROM ECCENTRIC LOAD. ATTENTION REQUIRED.

- BELL DECK BEAM REINFORCED MEMBER**
REINFORCEMENT ON A BELL DECK BEAM APPEARED UNDERSIZED AND INSUFFICIENTLY CONNECTED.
- BELL DECK JOINT DETERIORATION**
PROBING AT THE CENTRAL JOINT OF BELL DECK BEAMS SUGGESTED DETERIORATION WITHIN THE JOINT.

- LANTERN BEAM DETERIORATION**
A FLOOR BEAM IN THE LANTERN SECTION EXHIBITED DETERIORATION. THE EXTENT OF THE DETERIORATION IS UNKNOWN DUE TO ACCESSIBILITY.

- LANTERN-BELFRY POSTS**
THESE POSTS PROVIDE VERTICAL AND LATERAL SUPPORT FOR THE LANTERN AND SPIRE AND EXHIBIT SIGNIFICANT DETERIORATION. REINFORCING, SHORING, OR REPLACEMENT IS MANDATORY AND THE NUMBER ONE PRIORITY.

- LANTERN-BELFRY POST BEAMS AND SUPPLEMENTAL SUPPORT SYSTEM**
THE ORIGINAL LANTERN-BELFRY POST SUPPORT BEAMS AND THE SUPPLEMENTAL SUPPORT FOR THEM ARE INTERRELATED AND THE SECOND PRIORITY. THE INDEPENDENT FUNCTION OF THE ORIGINAL BEAMS HAS BEEN PARTIALLY REPLACED BY THE SUPPLEMENTAL SUPPORT SYSTEM. THE ORIGINAL MEMBERS ACT AS BLOCKING FOR VERTICAL SUPPORT AND ALSO PROVIDE LATERAL STABILITY TO THE SYSTEM. THE FUNCTION OF THE ORIGINAL BEAMS IS COMPROMISED EVEN AS PART OF THE SUPPLEMENTAL SYSTEM DUE TO DETERIORATION. THE SUPPLEMENTAL SYSTEM ITSELF REQUIRES IMPROVED CONNECTIONS AND STABILIZING.

- BELL DECK BEAM REINFORCED MEMBER AND CENTRAL JOINT DETERIORATION**
THE MAIN MEMBERS OF THE BELL DECK SUPPORT THE LARGE BELL AND WILL REQUIRE ADDITIONAL REINFORCEMENT OR REPLACEMENT.

- LANTERN-BELFRY POSTS**
(8) POSTS 13" SQUARE AND DIAMETER X 22'. (800#±)
REMEDATION
PATCH AND SPLICE: REMAINDER OF COLUMN MUST BE STRIPPED OF PAINT TO INSPECT. REMOVE PORTIONS OF BELLDECK SURROUNDING COLUMN. MAY REQUIRE STEEL SPLICE ELEMENTS. TEMPORARY SHORING REQUIRED. DOES NOT ALLOW LANTERN REPAIR OR BELLDECK INSPECTION OR REPAIR. PURPOSE IS TO ALLOW REPAIR WITHOUT LANTERN AND SPIRE REMOVAL.
REPLACE WITH BUILT-UP COLUMN: REPLACE WITH COLUMN COMPOSED OF 3 OR MORE FULL LENGTH PIECES WHICH ARE BOLTED TOGETHER FOLLOWING PLACEMENT. TEMPORARY SHORING REQUIRED. PURPOSE IS TO ALLOW REPAIR WITHOUT LANTERN AND SPIRE REMOVAL.
REPLACE WITH NEW COLUMNS: BELL SYSTEM, LANTERN, AND SPIRE REMOVAL REQUIRED. LIFTING FRAMEWORK AND CRANE REQUIRED. MOST HISTORICALLY ACCURATE AND STABLE. ALLOWS GROUND LEVEL LANTERN AND SPIRE INSPECTION AND REPAIR. ALLOWS BELLDECK REPAIR. ALLOWS LANTERN-BELFRY POST BEAM REPLACEMENT WITHOUT SHORING.

- LANTERN-BELFRY POST BEAMS**
(4) BEAMS 14"x13" X 14' (600#±)
REMEDATION
PATCH AND SPLICE: PROVIDE STEEL OR ENGINEERED LUMBER SPLICES ON EACH SIDE OF EXISTING BEAMS AS WELL AS ADDITIONAL POSTING IF NEEDED TO TRANSFER LOAD TO EXISTING STEEL BEAMS. CONNECTIONS TO LANTERN POSTS REQUIRES TEMPORARY JACKING TO TRANSFER LOAD TO NEW ELEMENTS. PURPOSE
REPLACE WITH NEW BEAMS (A): REPLACE WITH LANTERN IN PLACE. TEMPORARY SHORING REQUIRED. REPLACE BEAMS WITH BUILT UP MEMBERS THROUGH SIDE OF TOWER. TEMPORARY DECK OUTSIDE OF BELL TOWER MAY BE REQUIRED.
REPLACE WITH NEW BEAMS (B): REPLACE WITH LANTERN AND BELL DECK REMOVED. REPLACE ALL (4) BEAMS WITH FULL SIZE MEMBERS. CRANE CAN BE USED TO SET MEMBERS.

- SUPPLEMENTAL SUPPORT SYSTEM FOR LANTERN-BELFRY POST BEAMS**
UPPER PART / LOWER PART - ACTION DEPENDS ON PARTIAL OR FULL REPLACEMENT OF OTHER ELEMENTS
REMEDATION
PARTIAL POST AND BEAM REPAIR METHOD: UPPER AND LOWER SUPPLEMENTAL SUPPORT SYSTEM TO REMAIN.
FULL POST AND BEAM REPAIR METHOD: UPPER SUPPLEMENTAL SUPPORT SYSTEM TO BE REMOVED. LOWER SUPPORT SYSTEM INCLUDING CENTER POSTS AND STEEL BEAMS TO REMAIN. POSSIBLE REMOVAL UPON ANALYSIS OR ALTERNATE TRANSFER OF LOADS TO STEEL BEAMS.
STEEL BEAM TORSION TO BE ADDRESSED WITH THE BEAM OR TIE ROD ADJUSTMENT.
