DAMAGE AND CONDITION ASSESSMENT

DESIGNS AND ENGINEERED SOLUTIONS, LLC 114 SCOVILLE HILL ROAD, HARWINTON, CT Phone: 860.806.2094 email: MATTHEWSZYLO@GMAIL.COM	SCALE AS NOTED COM. NO. 17-106 DRAWN BY MCS DATE 05-23-17	BELL TOWER EVALUATION NORFOLK CONGREGATIONAL CHURCH BUILDING PLAN AND TOWER ELEVATION	DRAWING 5-1 SHEET NO. 1 NO. OF SHEETS 2
REV.	DESCRIPTION OF REVISION	DATE	APPR

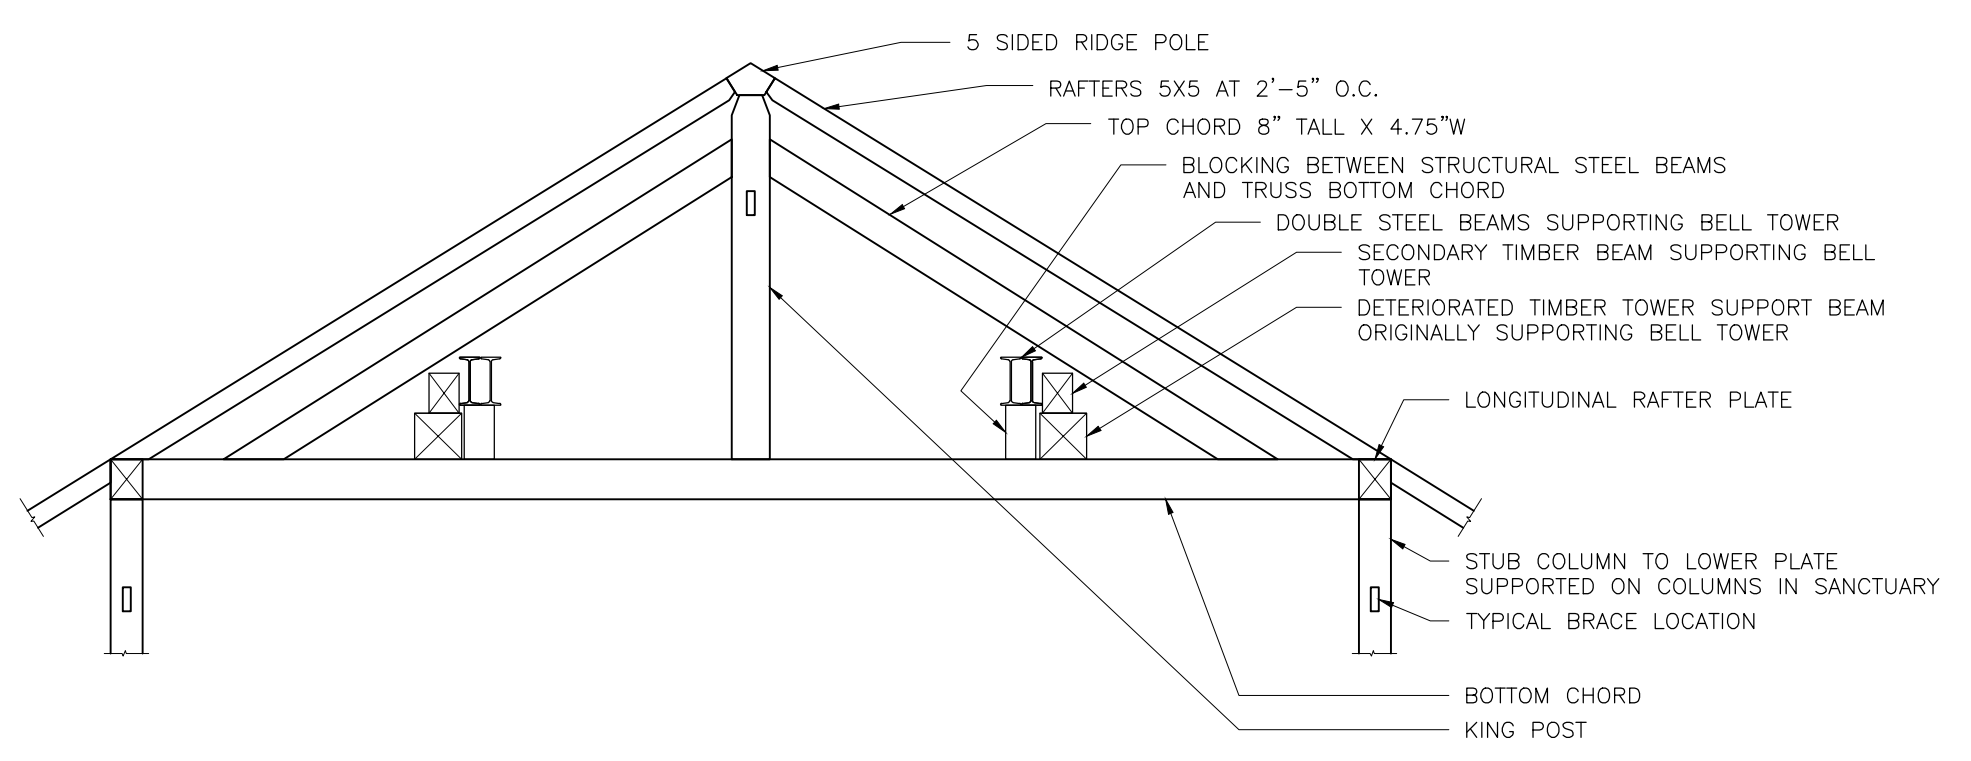
3 BELL TOWER SECTION AT WEST (REAR) FACE
SCALE: 1/4"=1'-0"

- LANTERN-BELFRY POSTS**
(8) POSTS 13" SQUARE AND DIAMETER. DECAY CONDITIONS FOUND AT BELLDECK LEVEL UP TO TWO FEET ABOVE. LOSS OF SIGNIFICANT PORTIONS OF CROSS SECTION (GREATER THAN 50% IN SOME CASES). CONDITION ABOVE THIS UNKNOWN.

- LANTERN-BELFRY POST BEAMS**
(3) OF (4) BEAMS EXHIBITED SIGNIFICANT DECAY. THE BEAMS THEMSELVES PROVIDE MINIMAL TO NO SUPPORT AT THIS TIME AND ARE FUNCTIONING AS BLOCKING TO TRANSFER LOAD TO SUPPLEMENTAL SUPPORTS. (1) OF (4) BEAMS HAS BEEN REPLACED AT AN EARLIER DATE AND DOES APPEAR TO BE FUNCTIONING ADEQUATELY.

- LANTERN BEAM DETERIORATION**
A FLOOR BEAM IN THE LANTERN SECTION EXHIBITED DETERIORATION. THE EXTENT OF THE DETERIORATION IS UNKNOWN DUE TO ACCESSIBILITY.

- LANTERN-BELFRY POSTS**
THESE POSTS PROVIDE VERTICAL AND LATERAL SUPPORT FOR THE LANTERN AND SPIRE AND EXHIBIT SIGNIFICANT DETERIORATION. REINFORCING, SHORING, OR REPLACEMENT IS MANDATORY AND THE NUMBER ONE PRIORITY.

- LANTERN-BELFRY POST BEAMS AND SUPPLEMENTAL SUPPORT SYSTEM**
THE ORIGINAL LANTERN-BELFRY POST SUPPORT BEAMS AND THE SUPPLEMENTAL SUPPORT FOR THEM ARE INTERRELATED AND THE SECOND PRIORITY. THE INDEPENDENT FUNCTION OF THE ORIGINAL BEAMS HAS BEEN PARTIALLY REPLACED BY THE SUPPLEMENTAL SUPPORT SYSTEM. THE ORIGINAL MEMBERS ACT AS BLOCKING FOR VERTICAL SUPPORT AND ALSO PROVIDE LATERAL STABILITY TO THE SYSTEM. THE FUNCTION OF THE ORIGINAL BEAMS IS COMPROMISED EVEN AS PART OF THE SUPPLEMENTAL SYSTEM DUE TO DETERIORATION. THE SUPPLEMENTAL SYSTEM ITSELF REQUIRES IMPROVED CONNECTIONS AND STABILIZING.

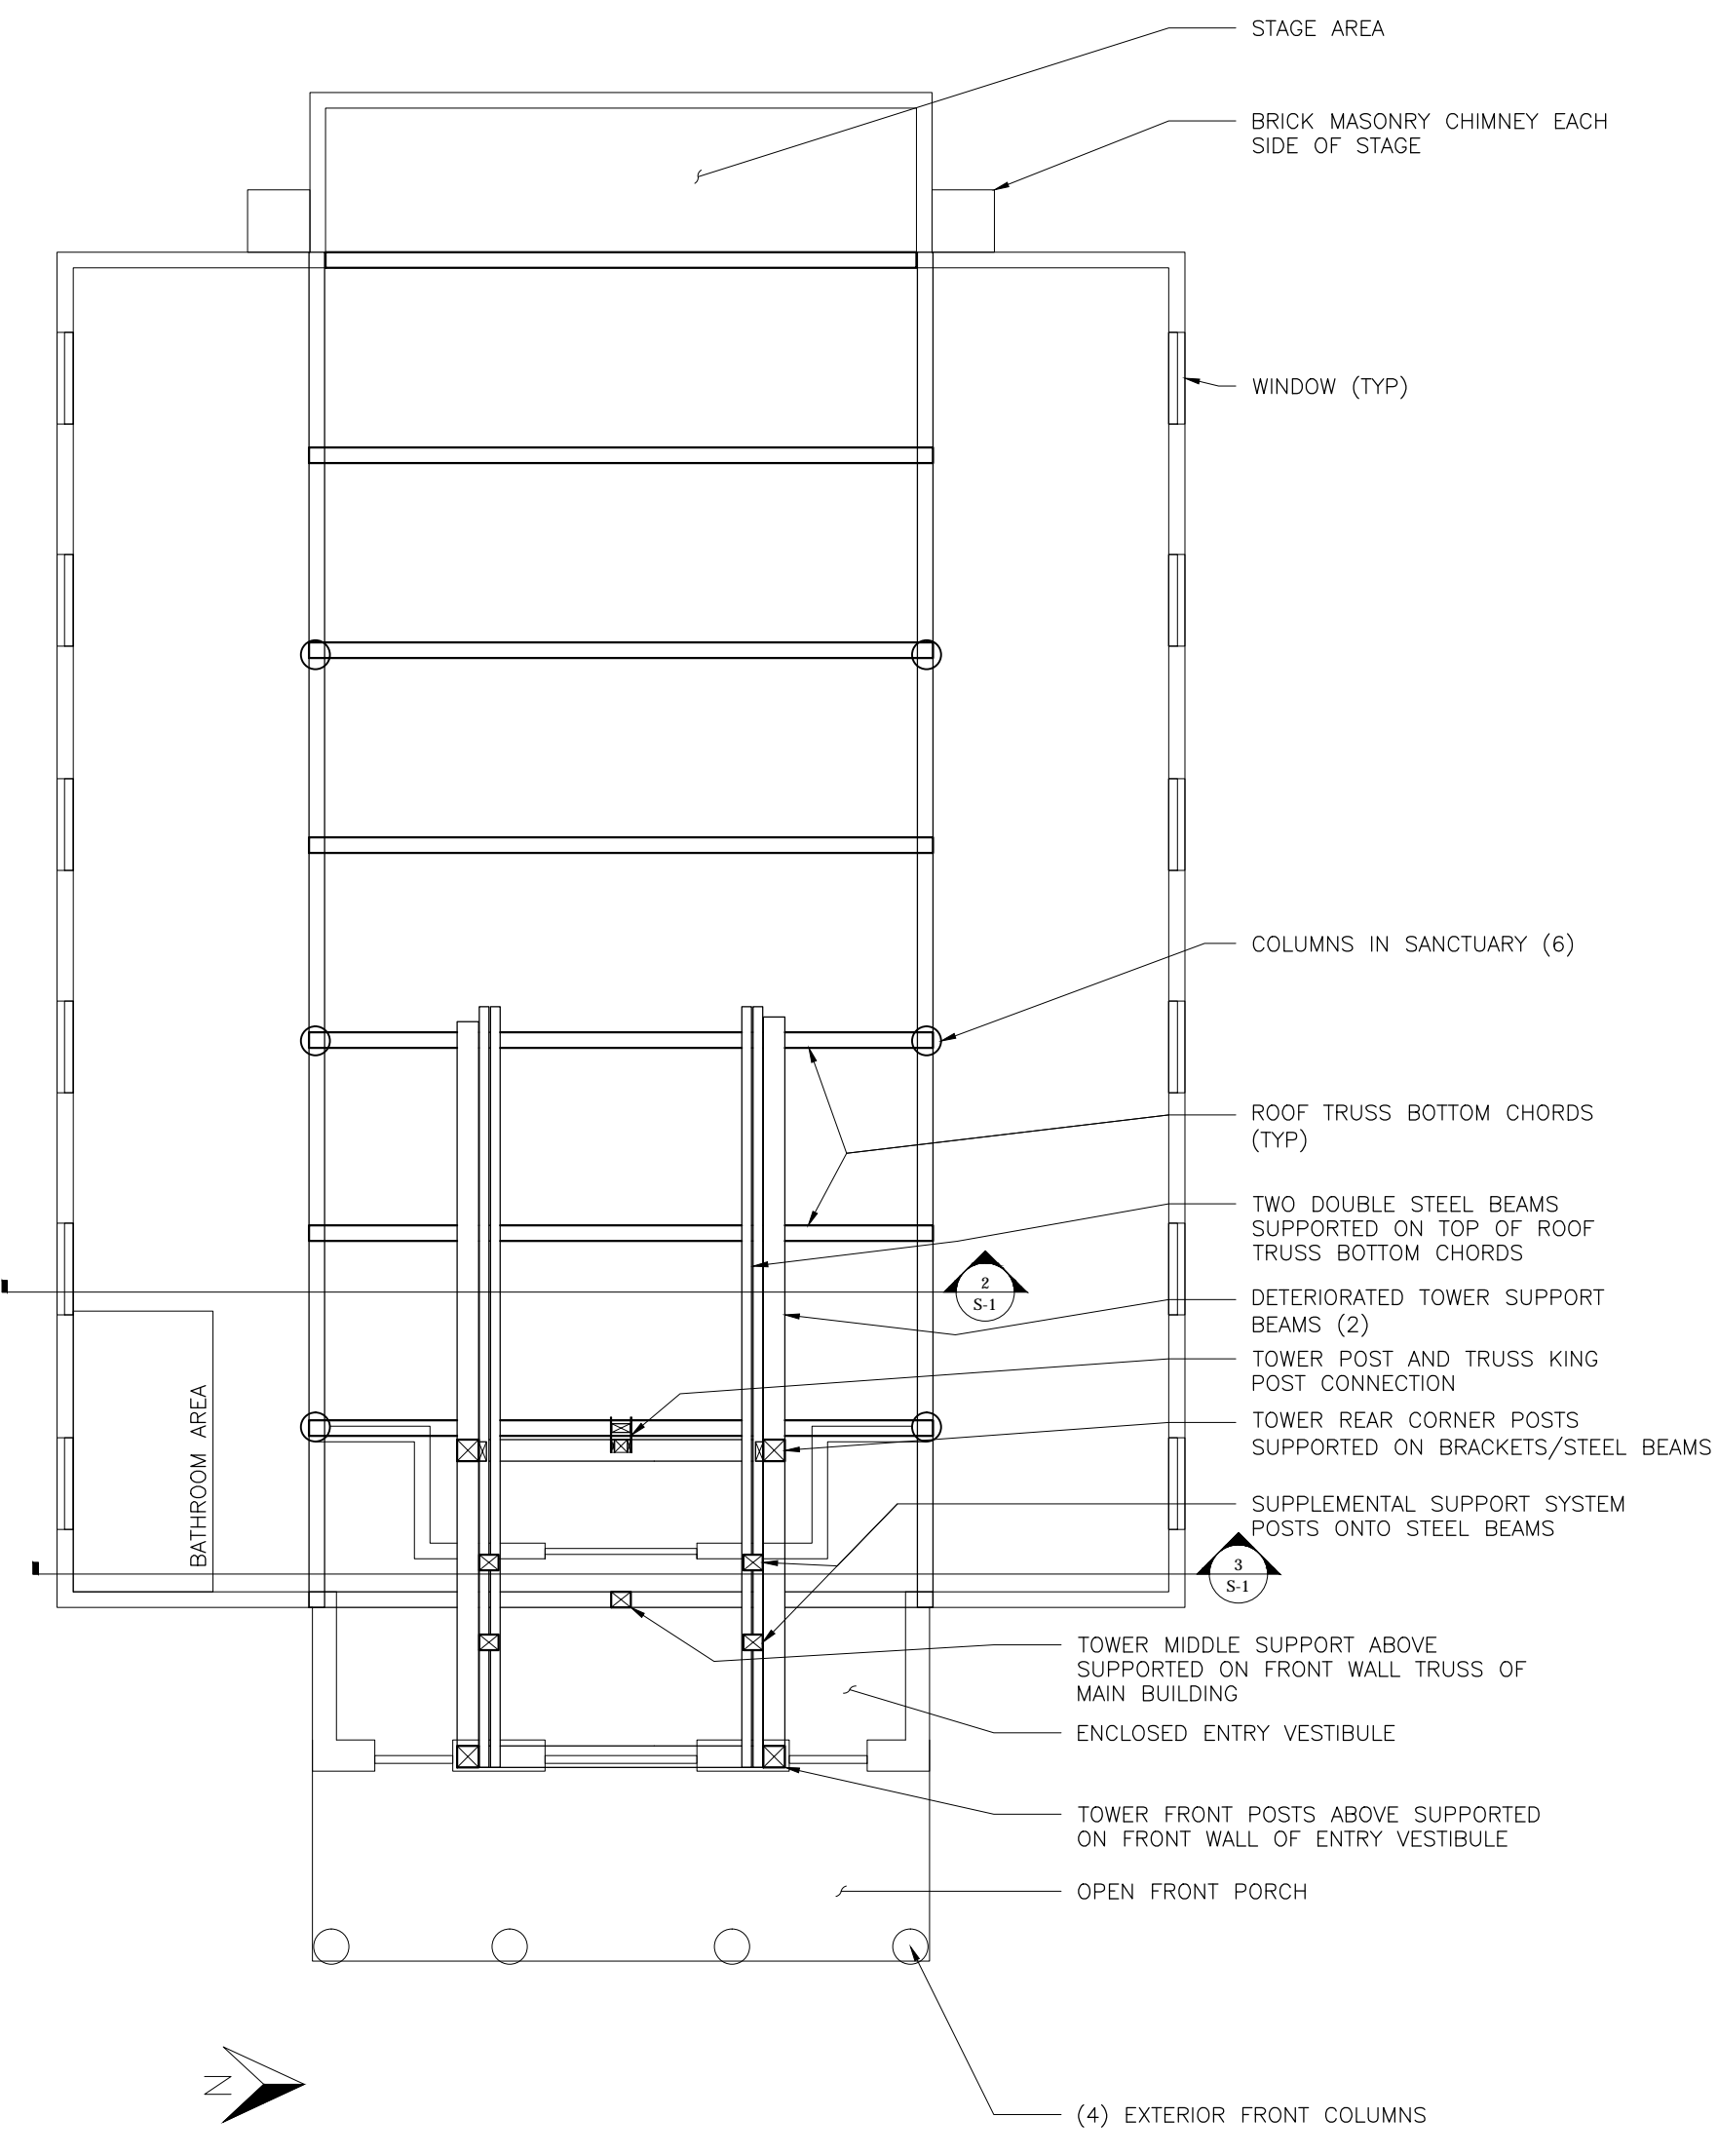
2 COMMON TRUSS SUPPORTING TOWER
SCALE: 1/4"=1'-0"

- SUPPLEMENTAL SUPPORT SYSTEM FOR LANTERN-BELFRY POST BEAMS**
THE ADDITIONAL SUPPORT SYSTEM FOR LANTERN-BELFRY POST BEAMS HAS BEEN ADDED AT A HISTORICAL TIME. THE SUPPORT SYSTEM CONSISTS OF AN UPPER AND LOWER PART. THE UPPER PART CONSISTS OF TWO BEAMS AND FOUR POSTS WHICH ARE BOLTED TO AND DIRECTLY SUPPORT LANTERN-BELFRY POSTS. THE LOWER PART CONSISTS OF BLOCKING, TWO WOOD BEAMS, FOUR WOOD POSTS, AND TWO STRUCTURAL STEEL BEAM ELEMENTS THAT SUPPORT THE LANTERN-BELFRY POST BEAMS. THE SUPPLEMENTAL SYSTEM PROVIDES ONLY PARTIAL SUPPORT FOR THE LANTERN BEAMS; POSTS AND COMPONENTS MAY BE UNDERSIZED. STEEL BEAMS EXHIBITED SOME TORSIONAL STRAINING (TWISTING).

- TOWER SUPPORT BEAMS**
ORIGINAL TOWER SUPPORT BEAMS EXHIBITED DETERIORATION AND HAVE BEEN REPLACED BY THE SUPPLEMENTAL SUPPORT SYSTEM STEEL BEAMS. BEAMS ARE TWISTING FROM ECCENTRIC LOAD. ATTENTION REQUIRED.
